ELECTRO-OPTICAL CABLE FOR USE IN TRANSMISSION OF HIGH VOLTAGE
AND OPTICAL SIGNALS UNDER EXTREMES OF TEMPERATURE AND
ALTITUDE

Tow/Signal Line Development

Phase C Thermal Upgrade Towline Flight Test Review

TDM033 Assessment

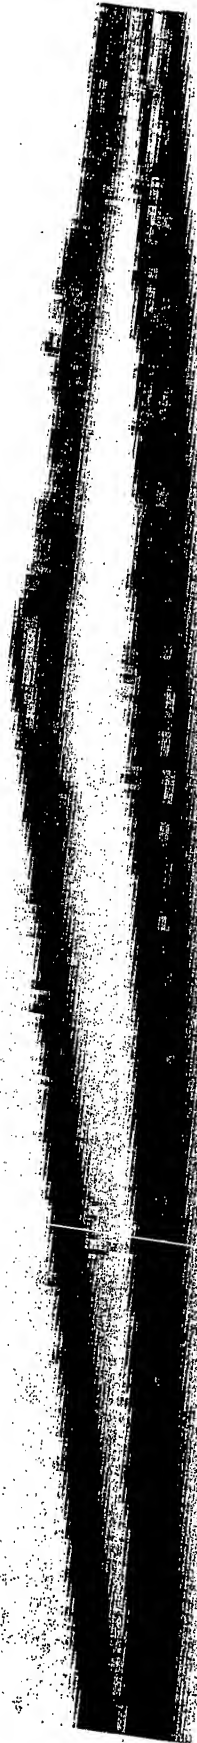
Baseline Cable Plume Damage

- F/A-18E/F Fast Deploy Test
- Plume induced heat damage during low AOA A/B maneuver
 - 2 seconds plume impingement
 - MILENE melted -> wire shorting
 - Fiber coatings flowed -> loss of optical continuity
- Laboratory testing shows milene melting begins @ 300°C

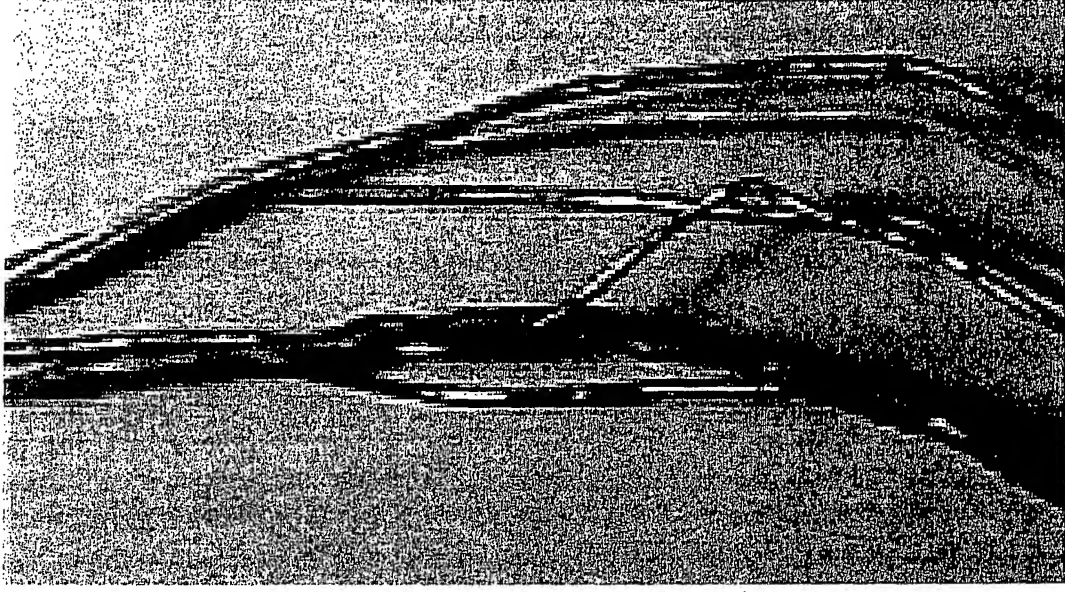
Baseline Cable Plume Damage

Plume induced A/B heat damage

- MILENE softened which resulted in shorting
- Fiber coatings flowed causing loss of optical continuity

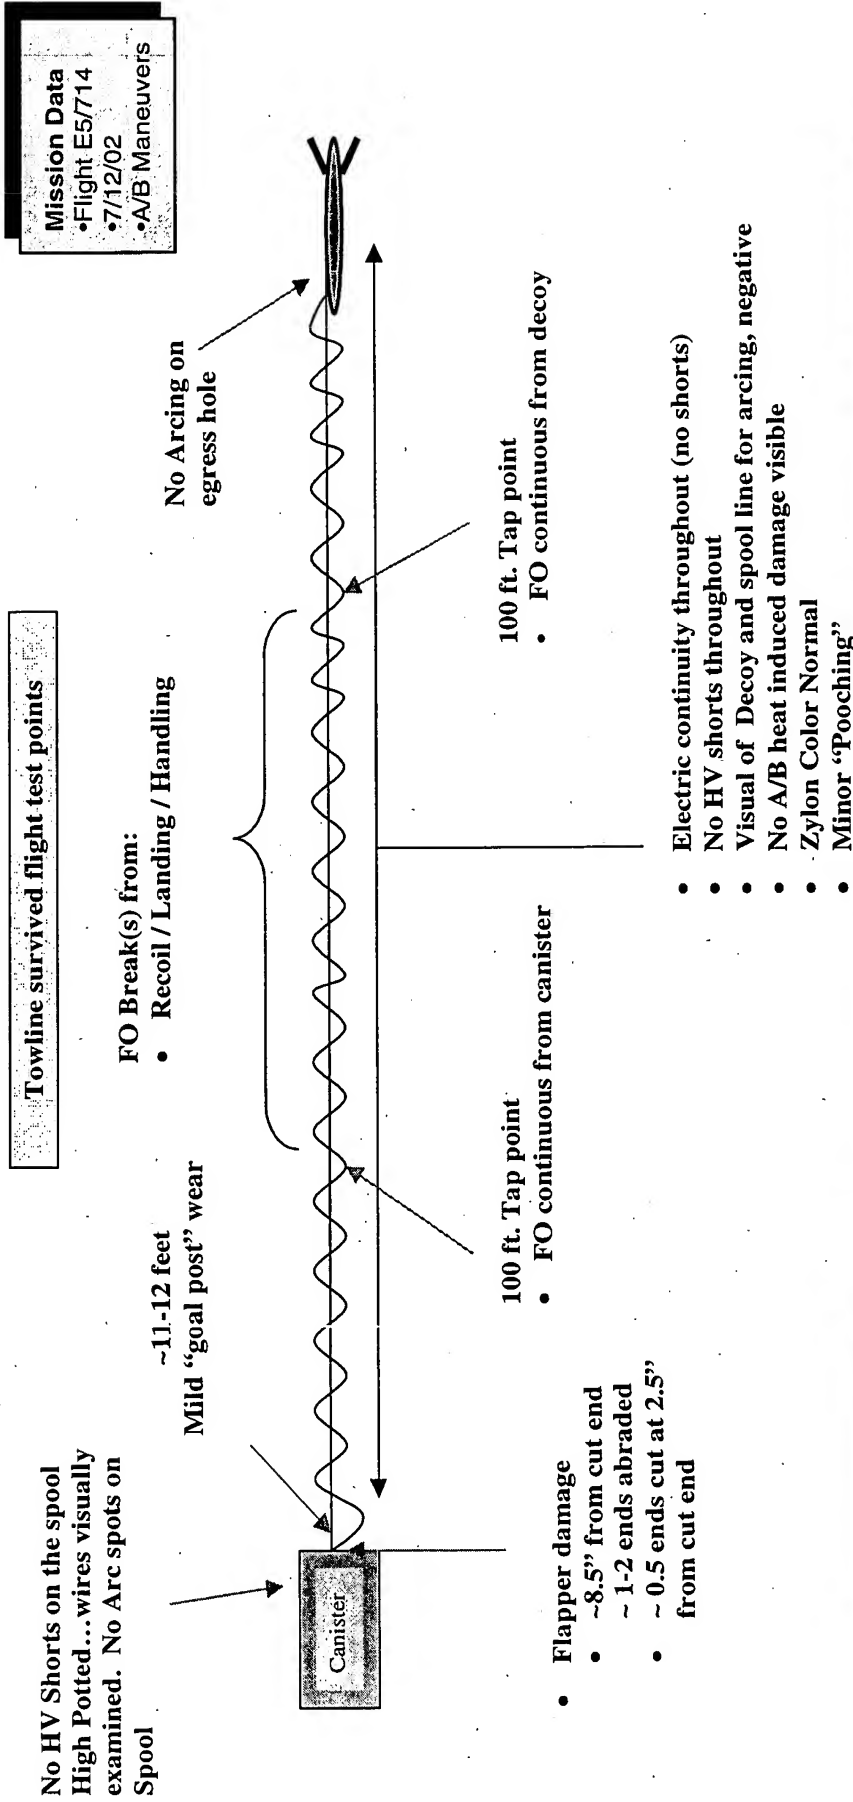
Representative of Fully Successful Flight

- Electric continuity throughout (no shorts)
- No HV shorts throughout
- No A/B heat induced damage visible
- Zylon Color little darker in 'Hot Zone'
- Minor "Pooching"

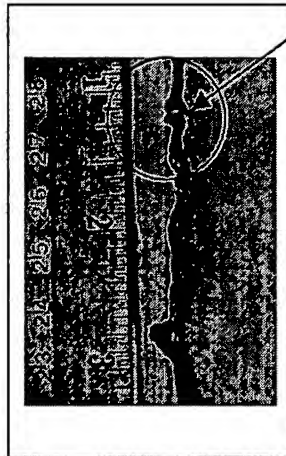
Representative of Heavy Twist Failure

- Severe Signal line pitch/twist (fiber failure region)
- Gore's "wire" pitch increased heavily
- PEEK Distortion
- Kinking

FIBER FAILURE

Decoy Sustained Damage During Landing

- Light Abrasion of Signal Line Through-out
- Zylon Color Normal
- No heat induced damage visible
- Electric continuity throughout (No Shorting)

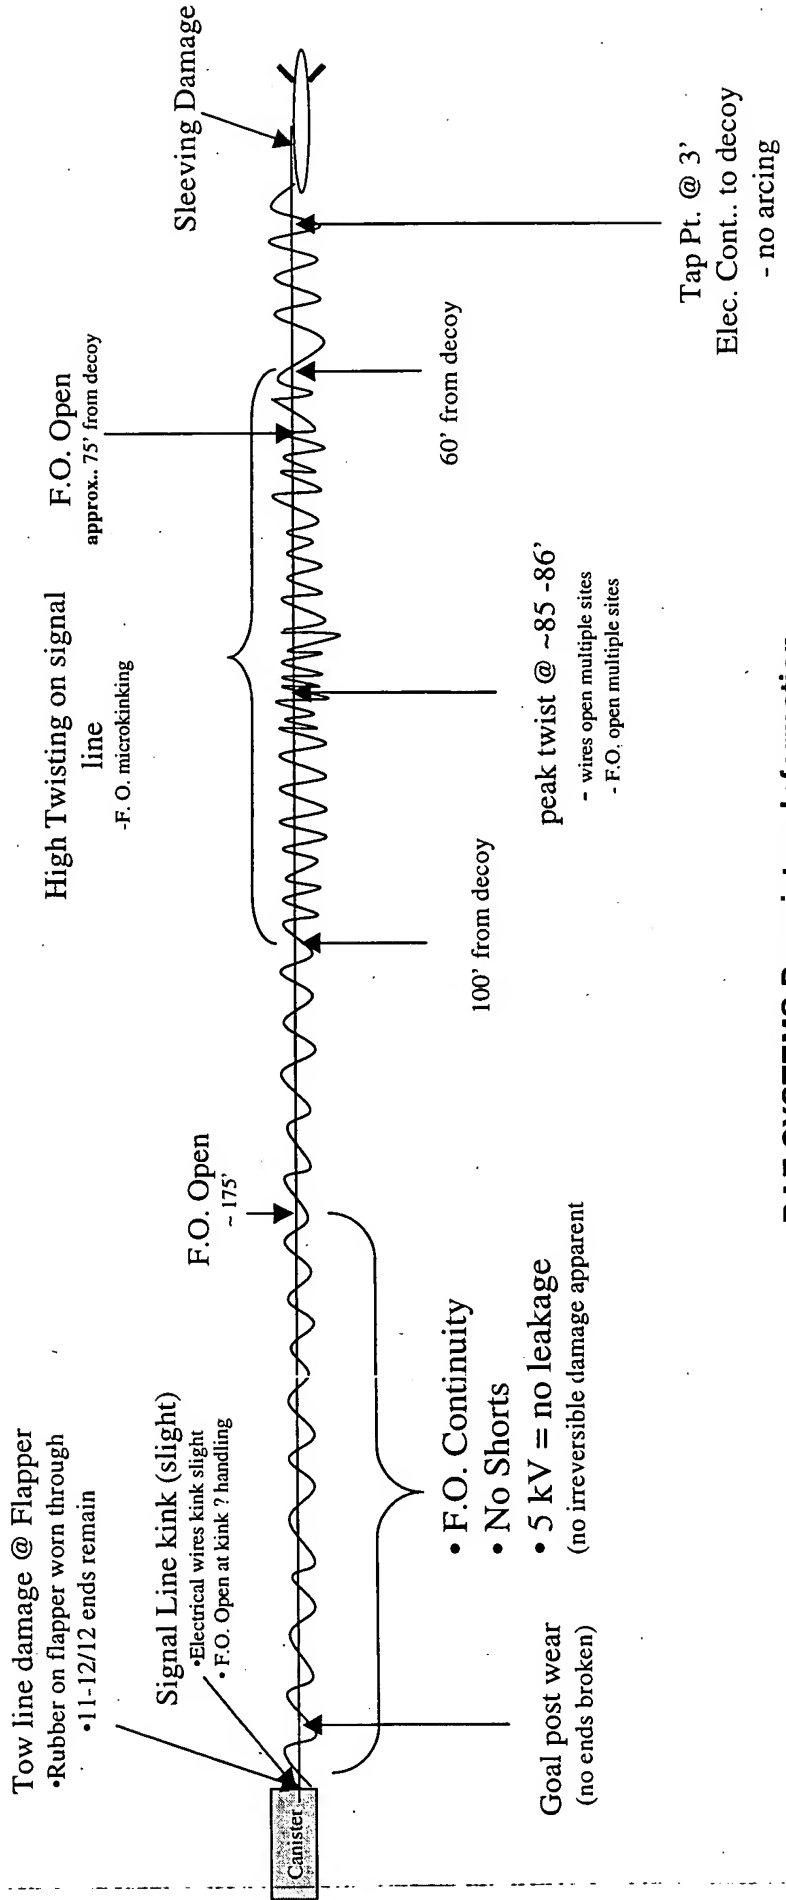
TDM018 Assessment

- F.O. open: 54 min.
- 350V open: 59 min.
- Intermittent shorts: 59 + min.
- Flight duration: 64 min.

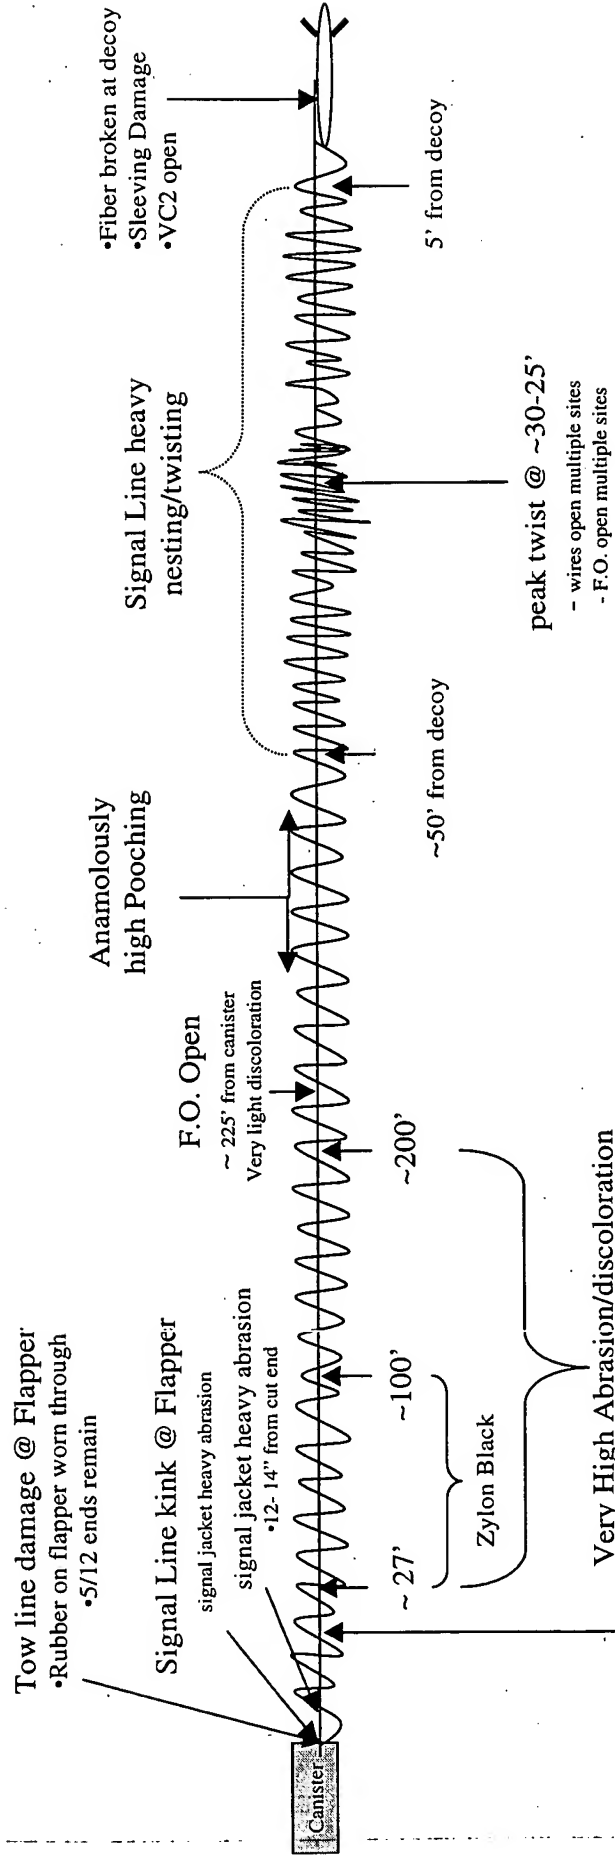
- F.O. open: 96 min.
- Vlk short to 350: 98min.
- Flight duration: 109 min.

- Goal post wear
(no ends broken)
- Light abrasion on Tow
 - light abrasion on Signal line 2 places

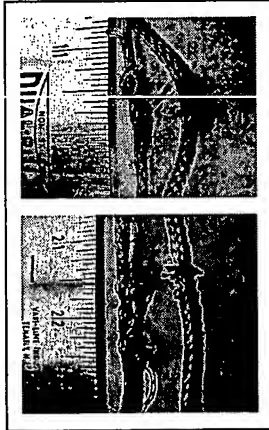
*Flapper damages (Signal)

- ~ 5" from cut end,
- ~ (9-10)/20 ends abraded/cut
- ~ 1.5 ends cut at 2.5" from cut end

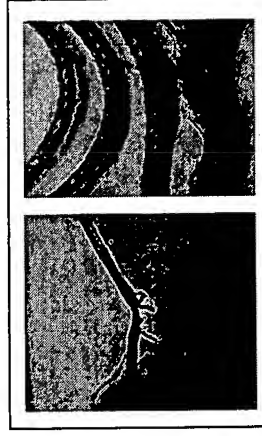
** Heavy burn on Zylon tow

** ~ 21 ft from can

- Excessive Arcing of wires
- 3 Wires open
- Protruding from jacket
- Based on electrical data...
 - Probable post damage. I.e. after line broke
- Insulation burned in 3mm from open on 2 wires

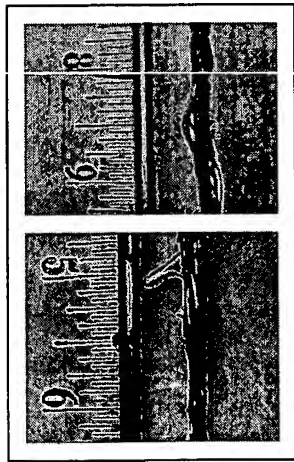
~80-90 ft. from canister:

- Uncoiled signal from tow
- * Abrasion (heaviest on cable)
- * Signal Zylon "spread-out"
- "Pooching"

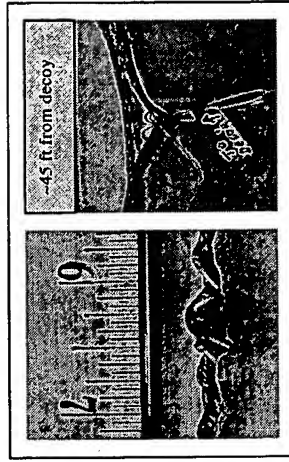
~40-55 ft from canister:

- Uncoiled Signal from Tow
- Loose wires ("Pooching")
- Minor abrasion

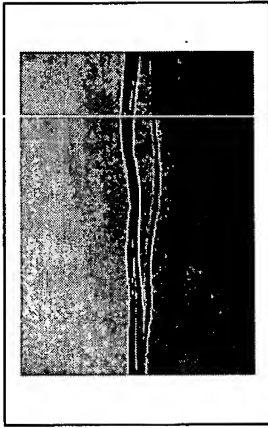
TDM 029

~80ft. From canister, Heavy twisting:

- Signal
- Poaching
- Gore pitch decreased to 1 twists/inch
- Heavy abrasion

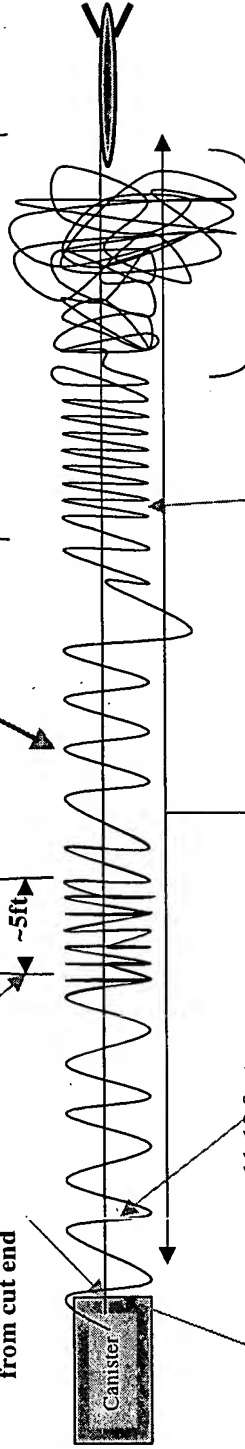
100-ft. tap point from can
• Fiber Optic continuous

~11-12 feet
Mild "goal post" wear

~6.5 ft. of Signal Line Missing
• Assorted Knotting of Signal on Towline
- Knot contains finger green marks

Signal pitch around tow very loose
